**STOCKTON
EAST WATER
DISTRICT**

TITLE: Calaveras River Bridges

RE: FIELD OBSERVATION OF SIXTEEN (16) BRIDGES ON THE OLD CALAVERAS RIVER TO DETERMINE STRUCTURAL INTEGRITY AND PROVIDE RECOMMENDATIONS FOR FURTHER STUDY AND ANALYSES.

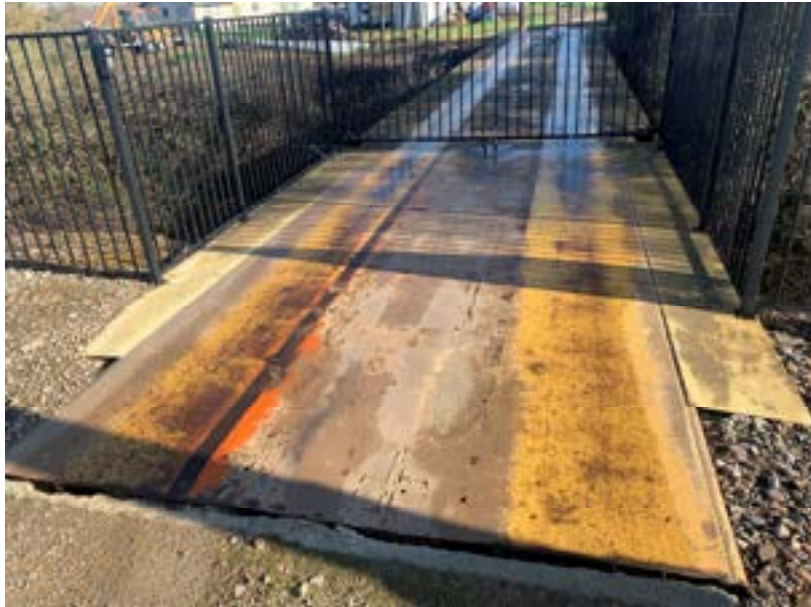
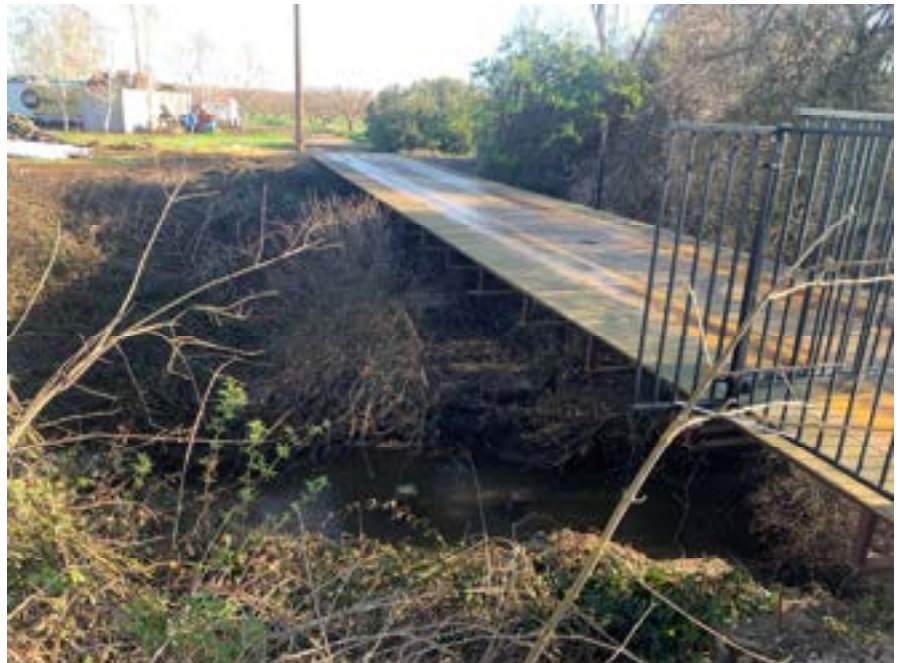
BRIDGE 1 GUTHERY

This bridge is constructed using a flatbed train car to span and is supported by concrete abutments at each end. The wood decking on top is in good condition. Abandoned existing (E) concrete piers were observed below. This bridge is very new.

This bridge appears in excellent condition. The installation of a guardrail should be considered for safety purposes. The current Code requires a guardrail where the step to adjacent grade is greater than thirty (30) inches.

Bridge Rating - 9.

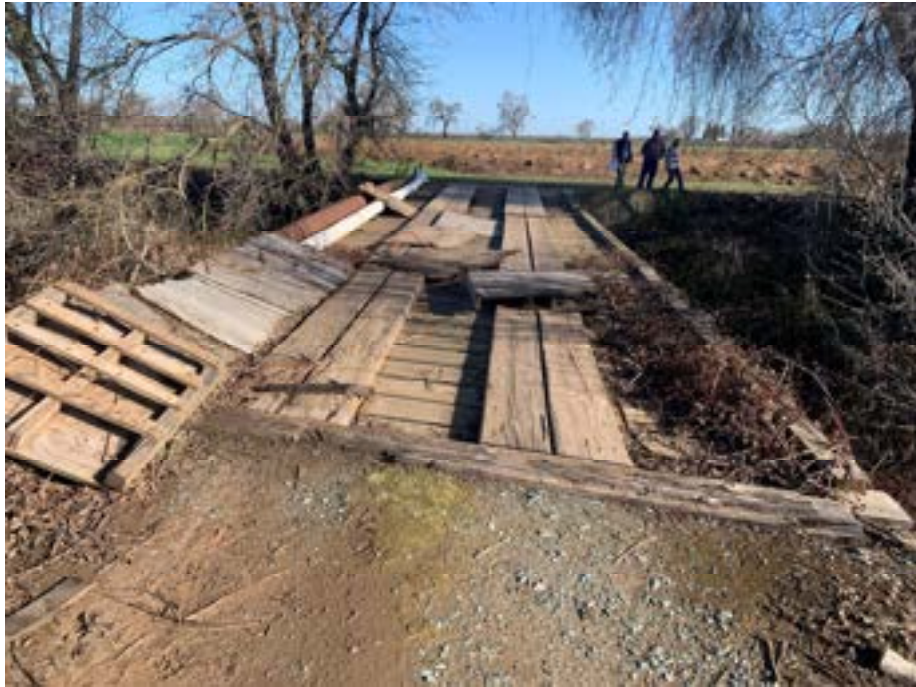
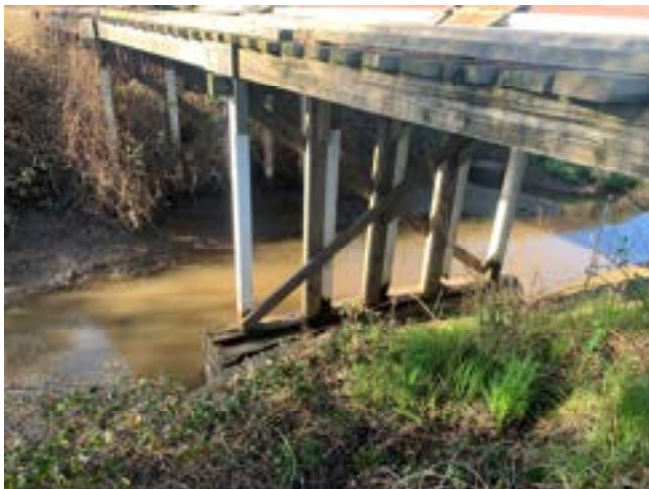
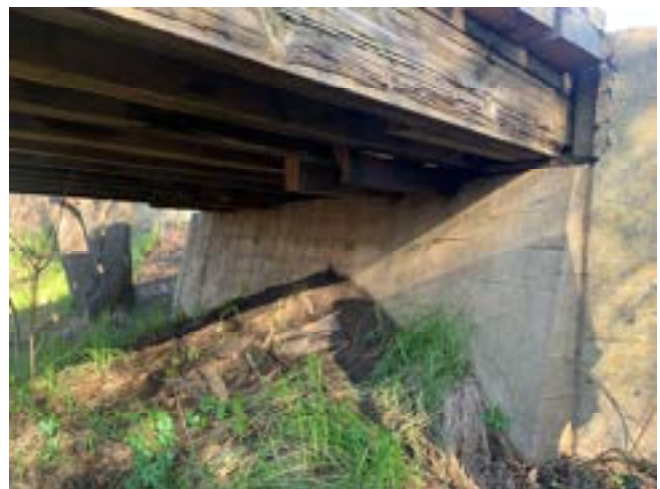
BRIDGE 2 RUGANI

This bridge is constructed with wood decking over wood beams. The wood beams span between concrete abutments at each end with two wood-framed cross supports in the span. Each cross support consists of a wood beam supported by wood posts bearing on a concrete grade beam footing. Three (3) newer 8x8 wood posts appear to have been added recently to the north cross-beam support. Some of the main 4x12 wood decking members have been replaced. No guardrail was observed.

Bridge Rating - 5.

Two (2) or Three (3) additional 8x8 supports should be added to the south cross-beam support similar to the north. Some of the 4x12 wood decking members need replacement soon. Additional 4x12 and/or 4x14 wood decking members will need to be replaced as they deteriorate. The installation of a guardrail should be considered for safety purposes. The current Code requires a guardrail where the step is greater than thirty (30) inches.

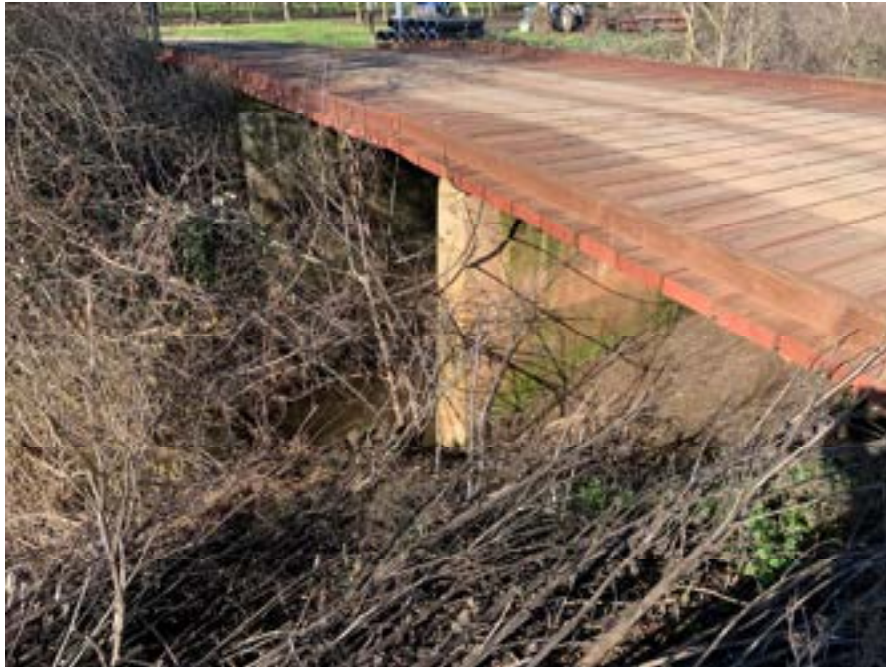
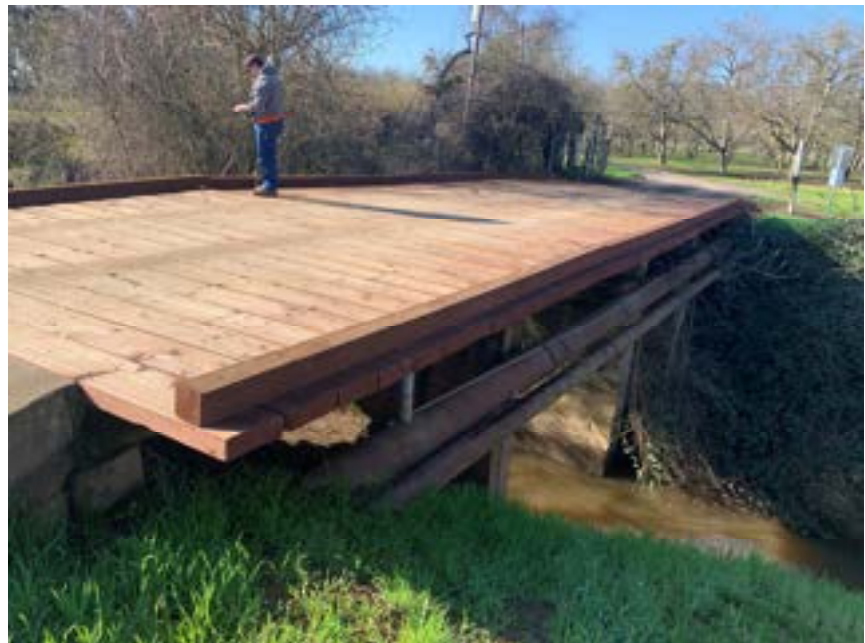
BRIDGE 3 WILLIAMS

This bridge is constructed with wood decking over wood beams. The wood beams span between concrete abutments at each end and two full-height concrete cross-support piers break up the span. This bridge appears very new. No guardrail was observed.

This bridge is in excellent condition. The installation of a guardrail should be considered for safety purposes. The current Code requires a guardrail where the step to adjacent grade is greater than thirty (30) inches.

Bridge Rating - 9.

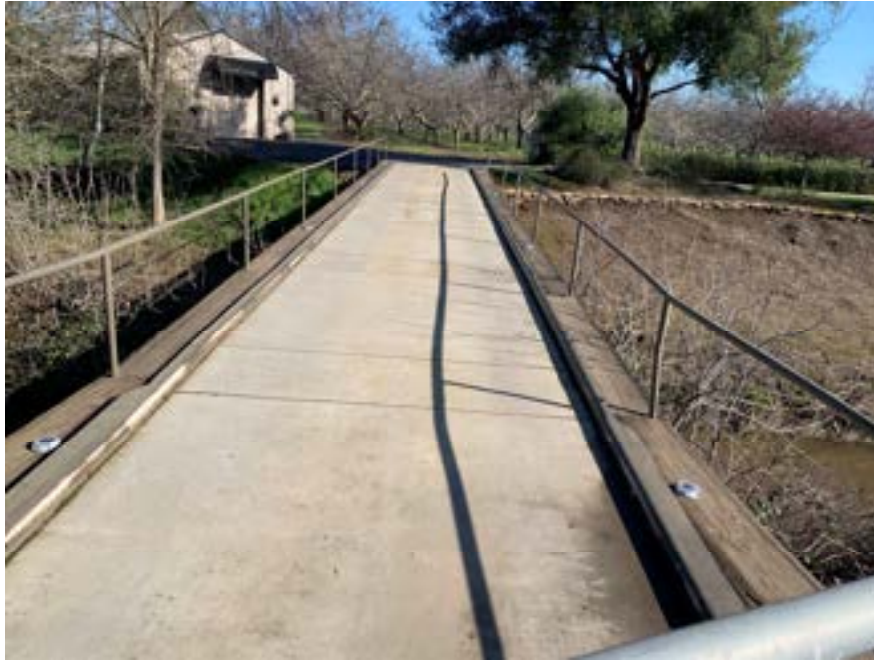
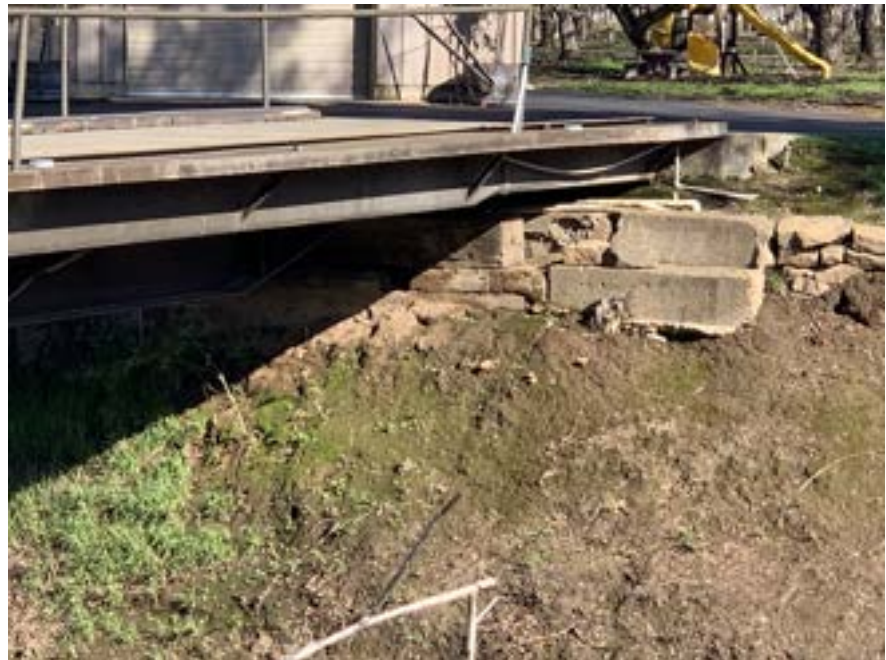
BRIDGE 4 BECKER

This bridge is constructed using a flatbed train car to span, concrete slab decking, and is supported by 8x8 wood plates bearing on concrete abutments at each end. The concrete decking on top is in good condition. A steel guardrail using steel pipes was observed on each side. The concrete abutments at each end are minimal but sufficient.

This bridge is in very good condition. The concrete abutments and 8x8 bearing plates should be monitored for potential future challenges.

Bridge Rating - 9

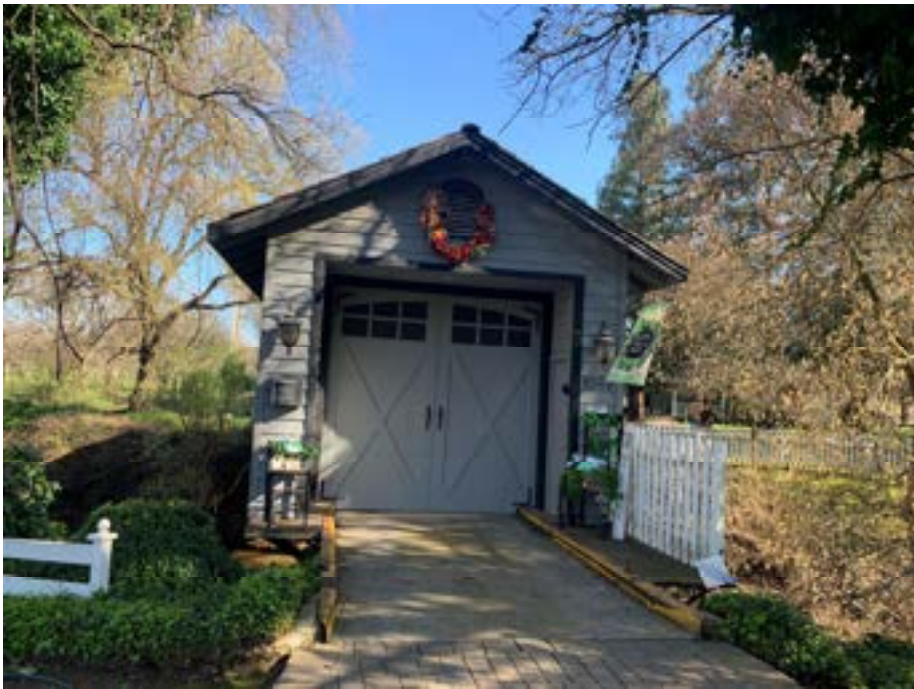
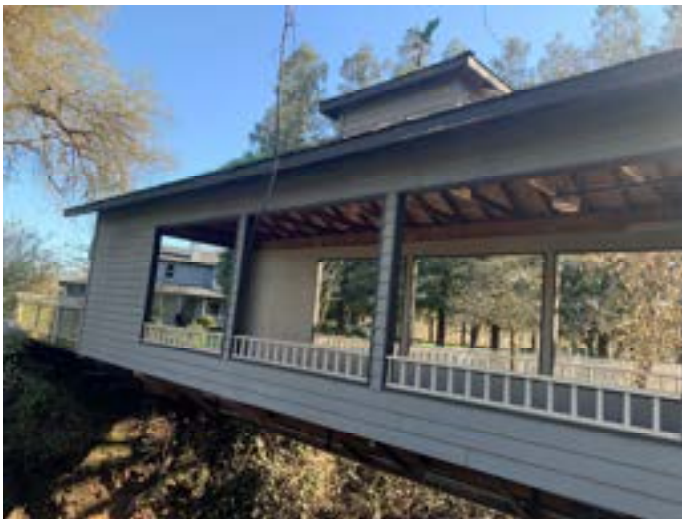
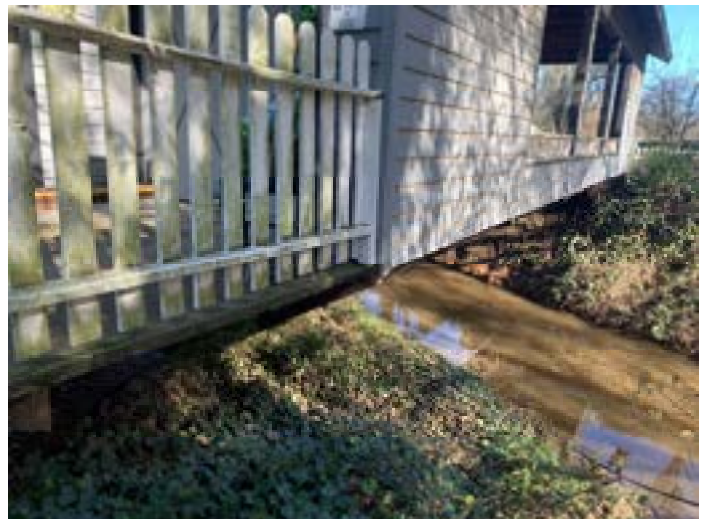
BRIDGE 5 NIXON

This covered bridge is constructed using a flatbed train car to span and is supported by concrete abutments at each end. The concrete decking on top is in good condition. The bridge is covered with wood-framed walls and roof. Openings along each side allow viewing of the slough and provide an appropriate guardrail.

This bridge is in excellent condition.

Bridge Rating - 10.

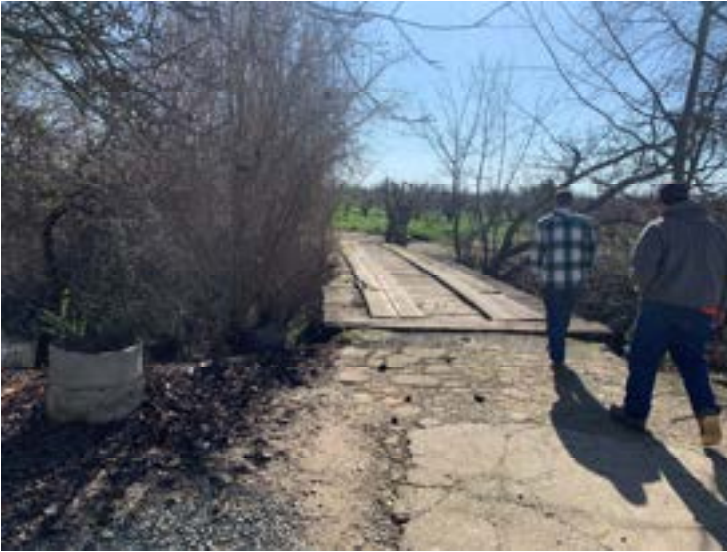
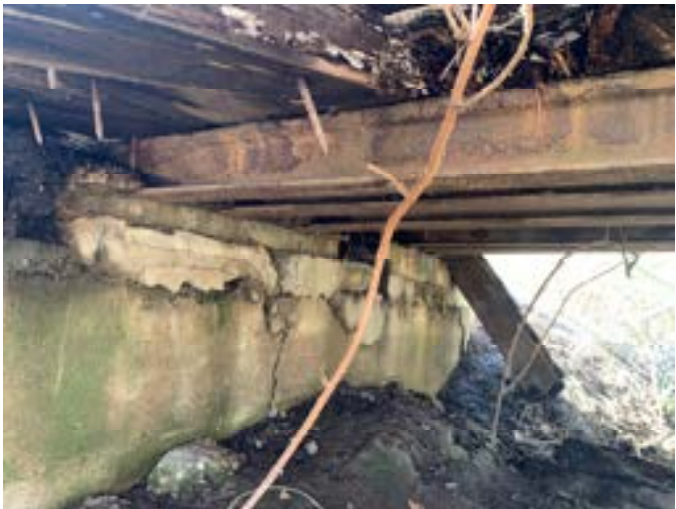
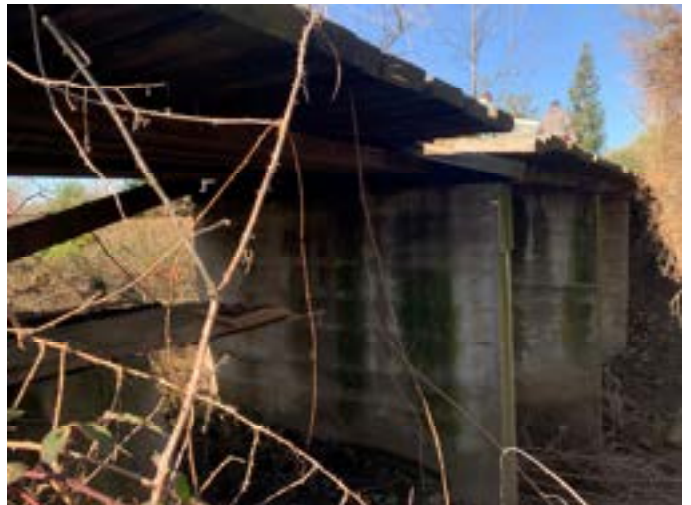
BRIDGE 6 VACCAREZZA

This bridge is constructed with wood decking over wood beams. The wood beams span between concrete abutments at each end and three (3) concrete cross-support piers break up the span. One of the concrete cross supports does not appear to provide any support to the bridge decking as there is no attachment. This bridge appears very old. The east end bay had been strengthened at some point using steel railroad track for beams. The concrete apron on the western end appears pretty dilapidated. The concrete abutments at each end exhibit cracks and appear to have been repaired multiple times. The concrete piers appear in relatively good condition. No guardrail was observed.

Bridge Rating - 3

This bridge is in very poor condition. The bridge decking should be removed and appropriate wood beams be provided to span between the supports. Consideration should be given to replacing the concrete abutments at each end soon. The installation of a guardrail should be considered for safety purposes. The current Code requires a guardrail where the step to adjacent grade is greater than thirty (30) inches.

For the short term, minimal use of the bridge can continue but repairs should commence within the next couple of years.

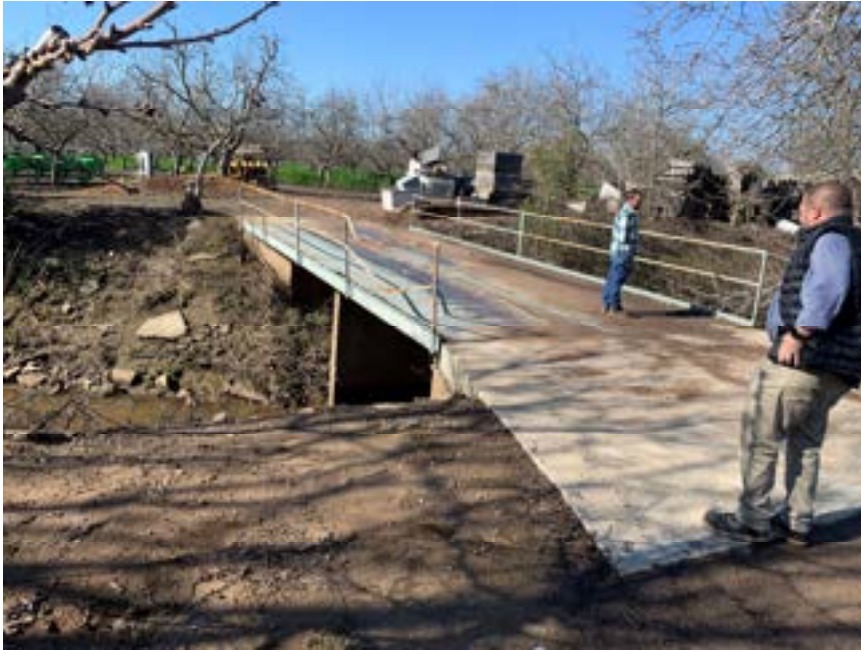
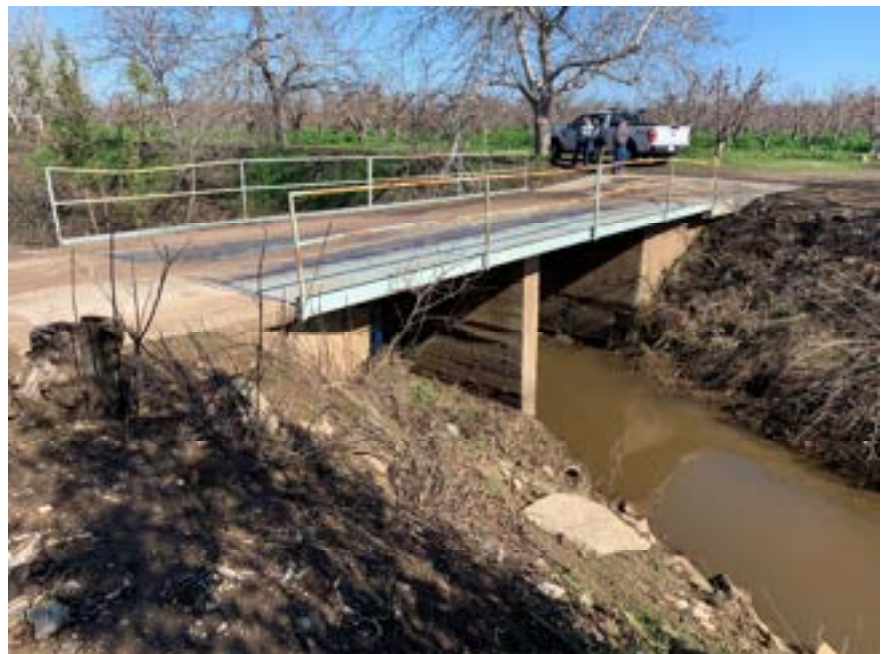
BRIDGE 7 CELUM

This bridge is constructed using a flatbed train car to span and is supported by concrete abutments at each end and a concrete cross-beam support in the

center. The steel plate decking on top is in adequate condition. The steel tubing guardrail has some deformation.

Bridge Rating - 8

This bridge is in very good condition. The bottom of one of the concrete abutments exhibits some deterioration and should be patched (see the end of this report for patching recommendations) to minimize future potential problems. Also, consider repairing the unsightly guardrail at some point.

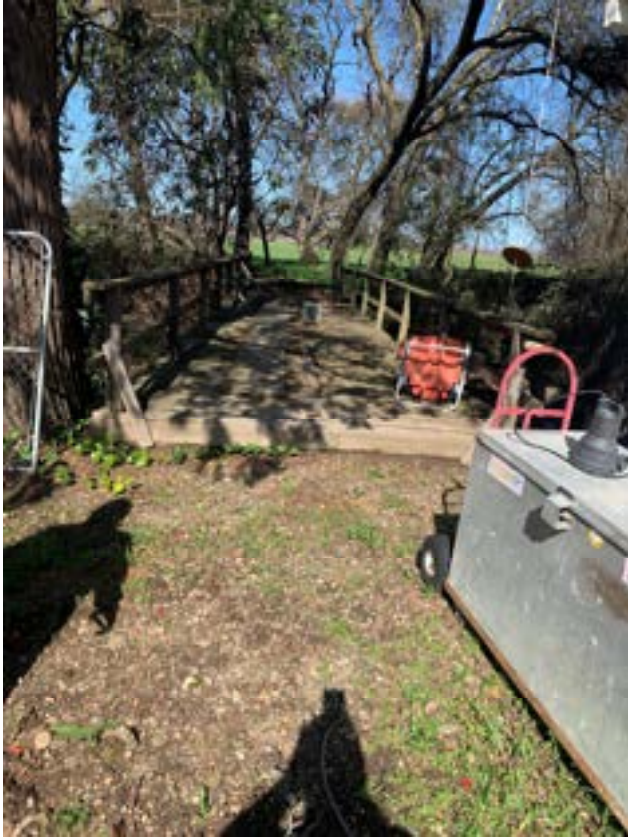
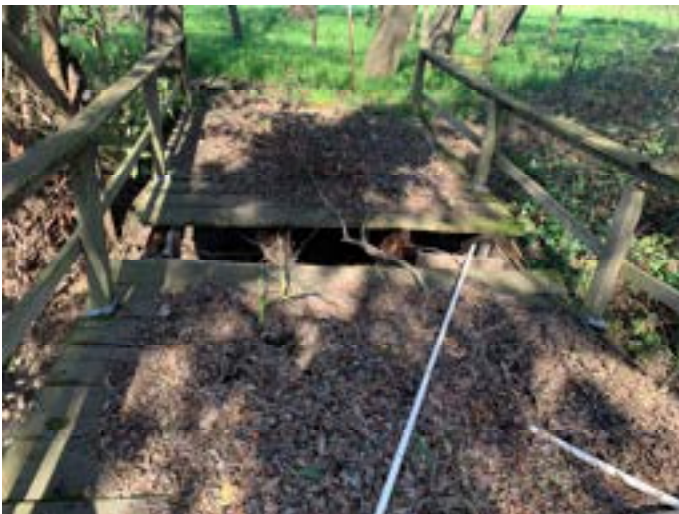
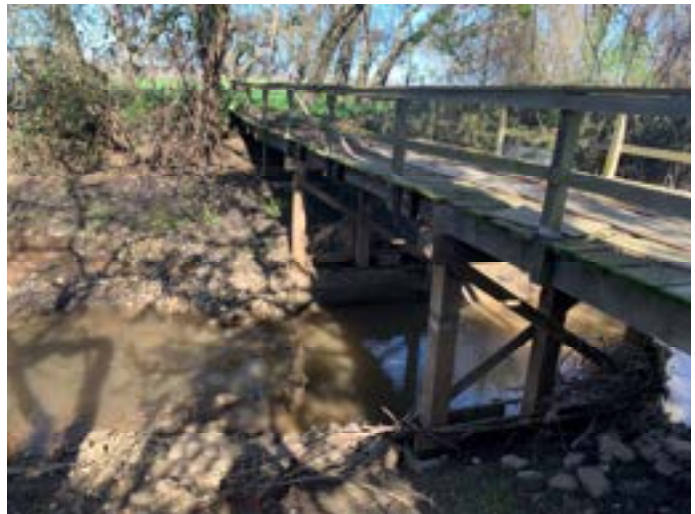
BRIDGE 8 REMINGTON

This bridge has wood decking supported by wood beams, wood cross-beam supports bearing on concrete grade-beams, and concrete abutments at each end. This bridge appears to be more of a footbridge and does not appear to go anywhere. A portion of the decking was broken towards one end. That end of the bridge was inaccessible. The wood decking and a couple of the beams are deteriorating and borderline unsafe. The wood cross beams, concrete footings, and concrete abutments appear adequate. A wood guardrail was observed.

Bridge Rating - 2.

This bridge is in very poor condition but could be rehabilitated. If continued use is desired, replace the damaged wood decking and beams where decay is observed.

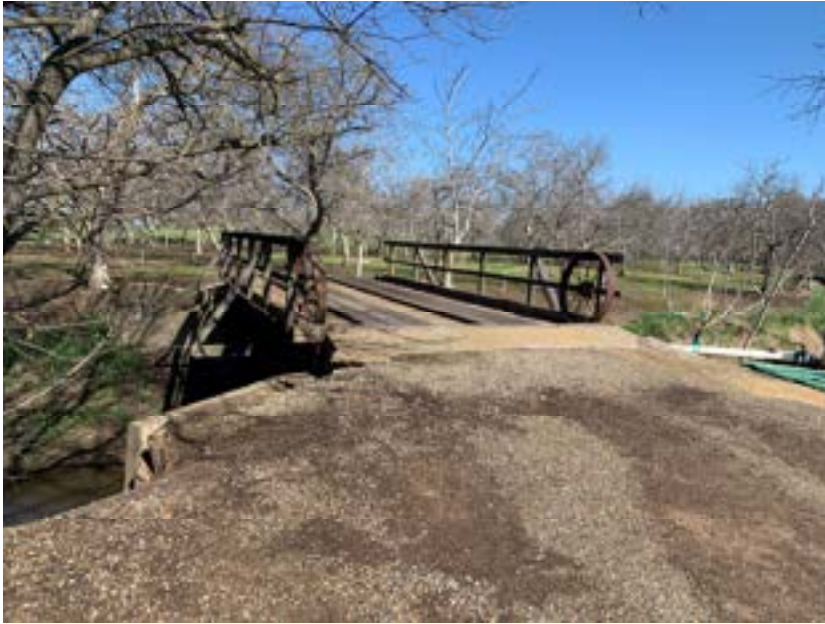
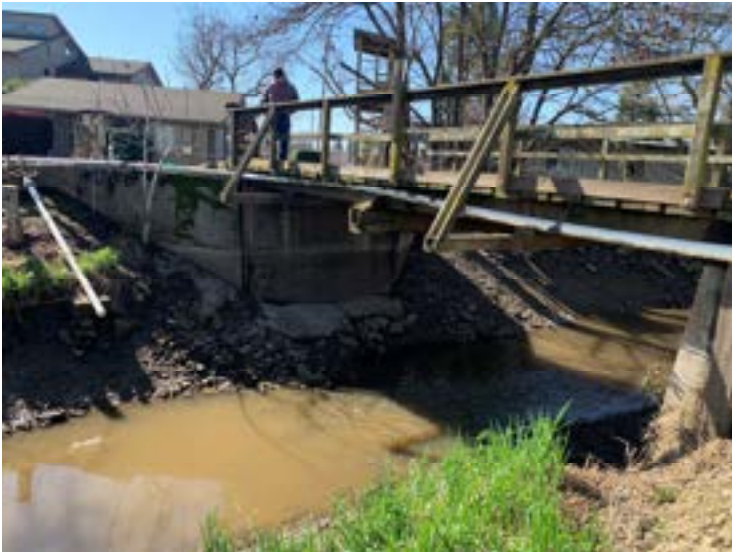
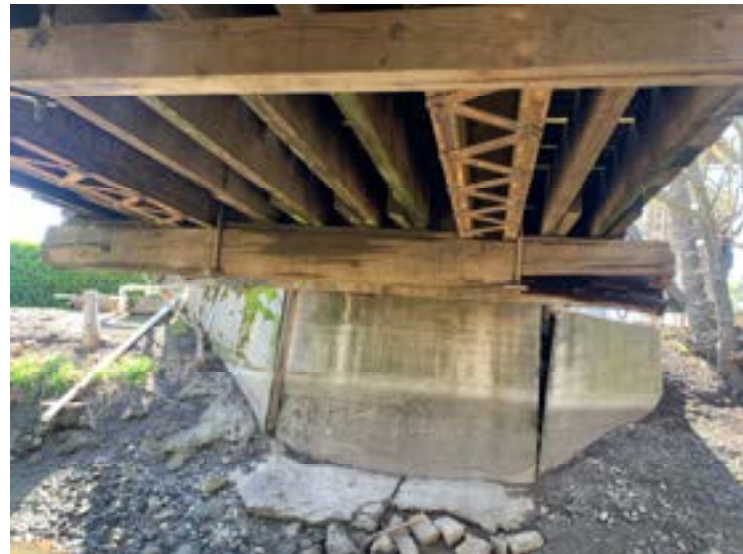
BRIDGE 9 BOTSFORD

This bridge has wood decking supported by steel assemblies that span between concrete abutments. The two steel assemblies are made up of steel channels with connecting steel plates to the top and bottom flanges in a crisscross pattern. The two assemblies span below the bridge to provide support for the vehicle tire path above. The steel assemblies span in the plane of the support beams. At the mid-span of the bridge, a wood cross beam hangs below the steel assemblies and is hung from them with rods and a steel plate above each steel assembly and below the cross beam. The concrete wing walls extending from the abutment have separated from the

main abutment. On one end, the wing wall was constructed of wood. A wood guardrail was observed.

Bridge Rating - 6.

This bridge appears in decent condition. The center wood cross beam appears to be deteriorating and will probably need to be replaced soon. The separation between the concrete abutment and the wing walls should be filled in with appropriate cementitious material and, possibly, doweled rebar. The wood wing wall should be replaced with concrete when feasible. Wood retaining walls perform very poorly in the long term.

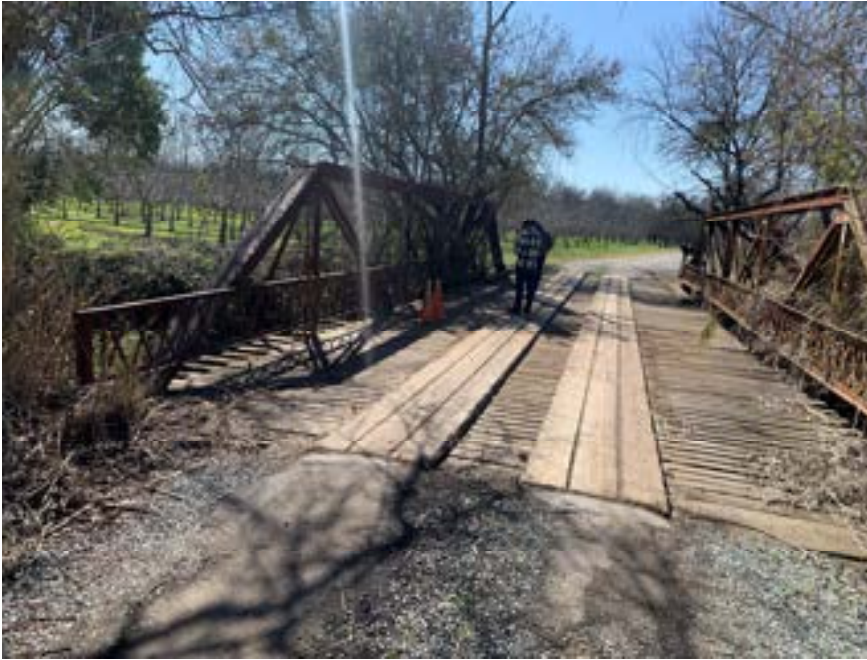
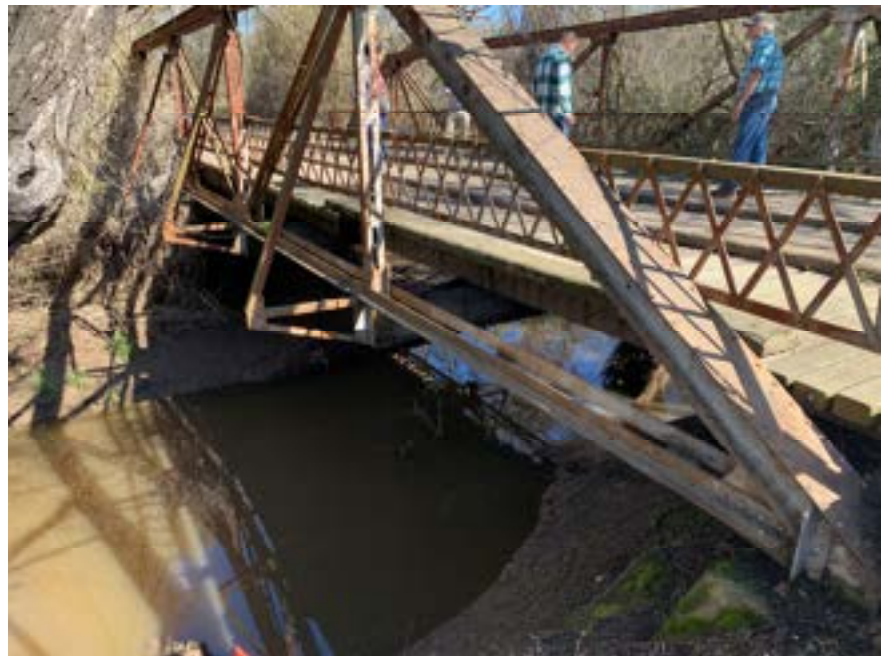
BRIDGE 10 HOUSTON

This bridge has wood decking supported by wood cross beams that span between two army surplus steel trusses. The wood cross beams are supported at each end by the steel trusses at a panel point. The wood decking looks relatively new and was probably replaced 6-9 years ago. The trusses bear at each end on concrete abutments. An anomaly on the bridge along one edge resulted in a broken 4x6 wood decking member along an edge. The normal edge beam over most of the bridge does not exist at one of the truss bays resulting in insufficient vertical support. A steel guardrail could be observed on each side attached to the steel truss.

Bridge Rating - 7.

This bridge is in pretty good condition. Replace the missing deck beam to span between the truss panel points to match the existing beams throughout the rest of the deck. Replace the broken 4x6 decking member as well. The steel trusses are very old so should be checked often to make sure no dilapidating steel members and/or bolts could cause future structural challenges.

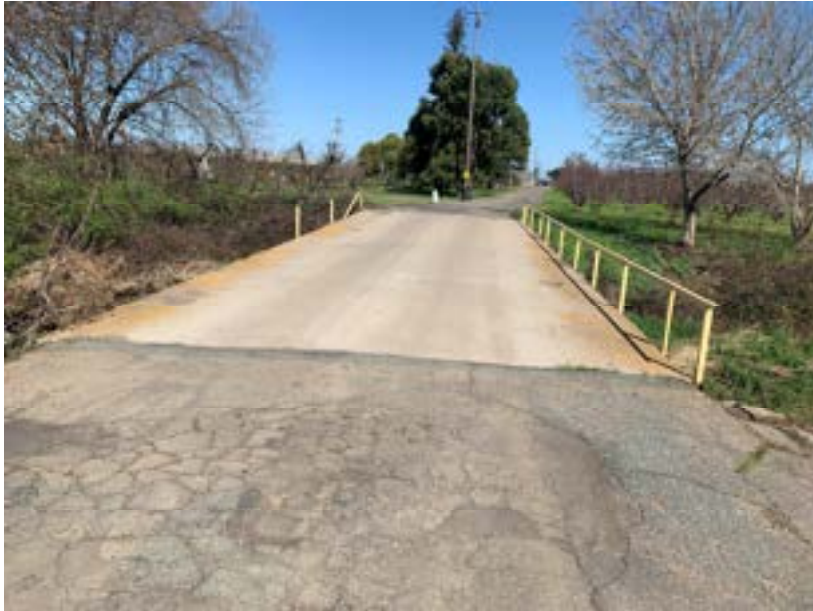
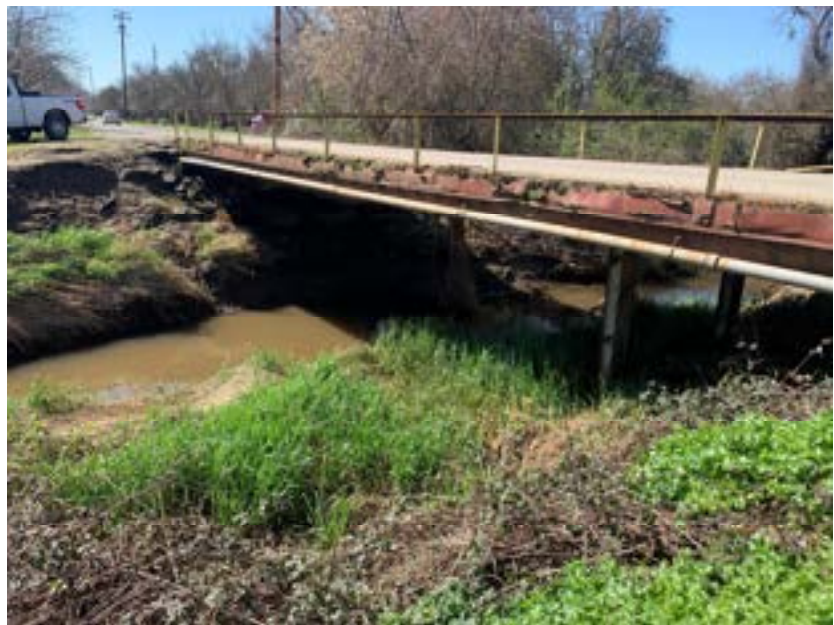
BRIDGE 11 DEMARTINI #2

This bridge is constructed using a flatbed train car to span and is supported by concrete abutments at each end and two (2) cross-beam supports breaking up the span. The concrete bridge topping is in very good condition. The light gage metal edges of the train car on each side appear very

unsightly but do not appear structurally significant at this time. At one of the two cross-beams, one of the columns is missing. The guardrail has some deformation and is missing over a good portion of one side.

Bridge Rating - 6.

This bridge is in fairly good condition. The missing column should be replaced in the very near future to match the existing columns that remain. This will minimize the potential for future unbalanced structural bridge difficulties. The missing guardrail and damaged portion should be replaced. One corner of one of the approach aprons has some erosion that should be strengthened to minimize potential future problems.

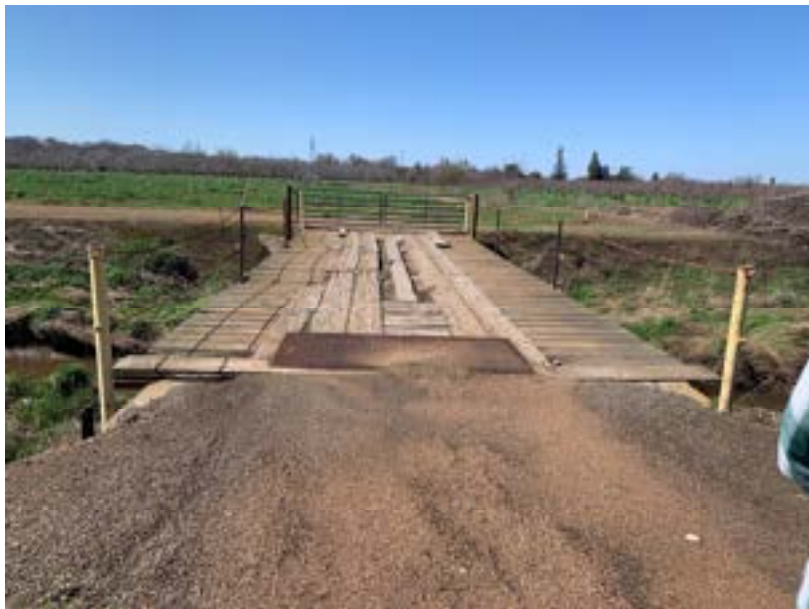
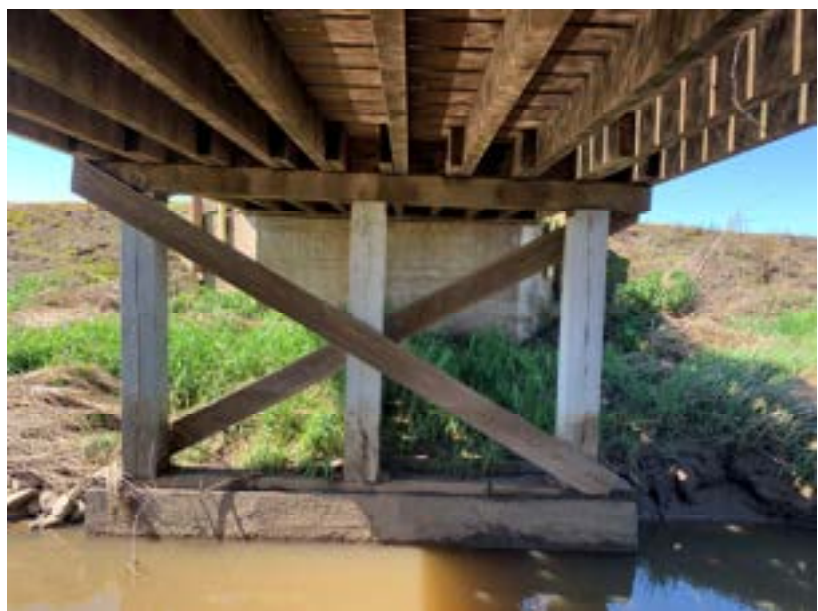
BRIDGE 12 DEMARTINI #1

This bridge has wood decking supported by wood beams, wood cross-beam supports, and concrete abutments at each end. Two (2) wood cross beams were supported with wood posts below bearing on a concrete footing on grade. Portions of the decking appeared severely dilapidated and covered with steel mesh. A minimal cable guardrail could be observed with posts lagged to the edge of the wood decking.

Bridge Rating - 5.

This bridge appears in fairly good condition but requires work. The support structure is in good shape but the wood decking needs repair and replacement. One beam appears more dilapidated than the others and replacement in the new future needs to be considered. The replacement of the guardrail should be considered for safety purposes. The existing cables are minimal.

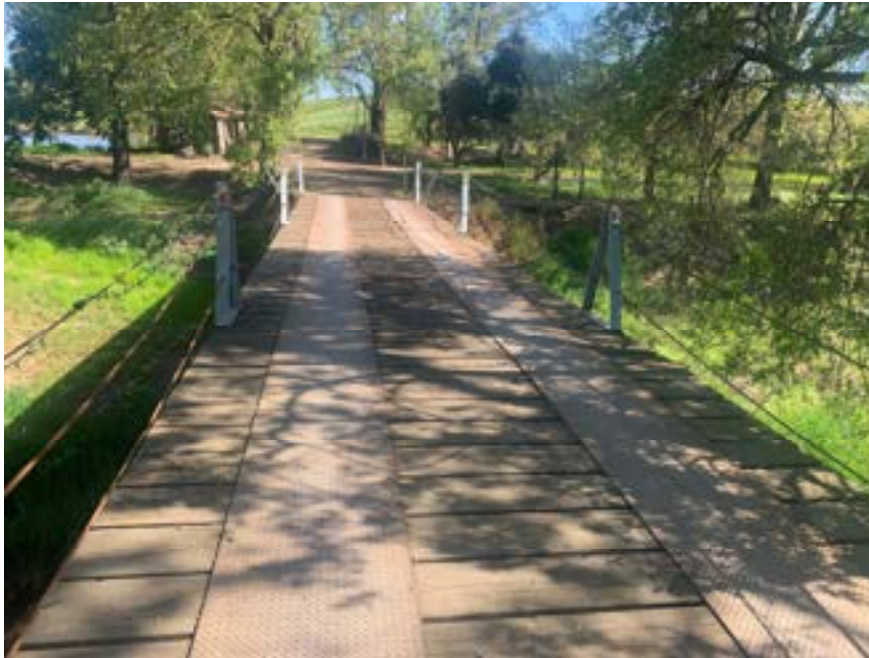
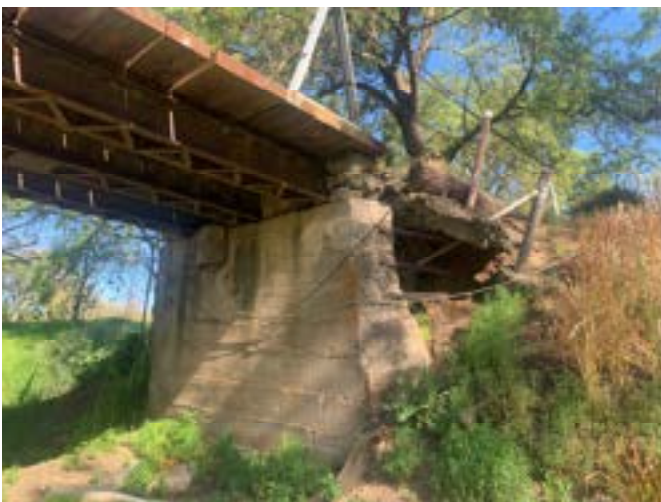
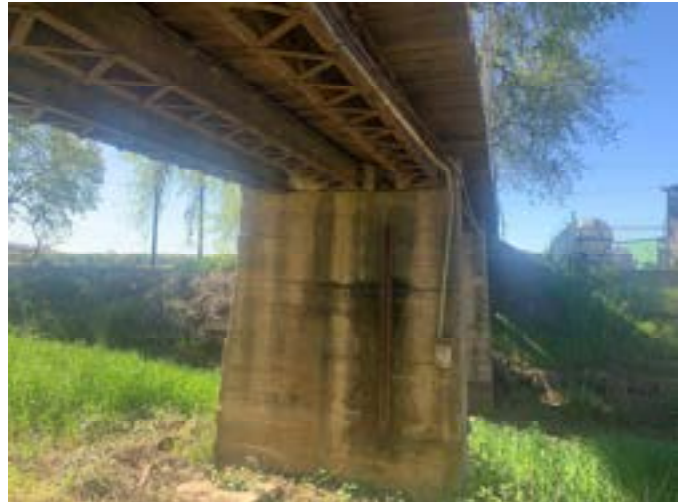
BRIDGE 13 SUNBURY FARMS

This bridge has wood decking supported by steel assembly beams and concrete abutments at each end. Steel diamond plates define the drive path on the surface. Two (2) concrete cross piers support three (3) steel assembly beams that support the wood decking directly. The steel assemblies are made up of steel channels with connecting steel plates to the top and bottom flanges in a crisscross pattern. The steel assemblies span below the

bridge to provide support for the vehicle tire path above. One of the concrete abutments has no concrete wing walls and exhibits severe undermining on the side. A minimal cable guardrail could be observed on each side of the bridge with post base plates lagged at the edge of the wood decking.

Bridge Rating - 4.

This bridge appears in adequate condition but requires work. A new concrete abutment needs to be provided at the undermined area to minimize potential future abutment difficulties. The new wing walls need to be doweled to the existing abutment and extend far enough outward that erosion of the hillside does not affect the abutment. The steel in the steel assembly beams needs to be monitored as it is deteriorating and will require replacement at some point in the not-too-distant future. The replacement of the guardrail should be considered for safety purposes. The existing cables are minimal.

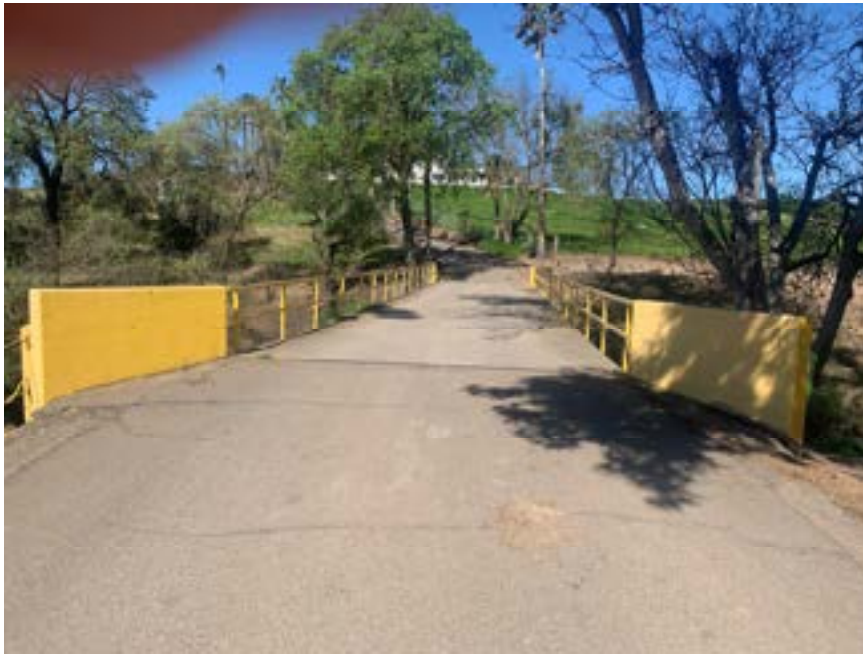
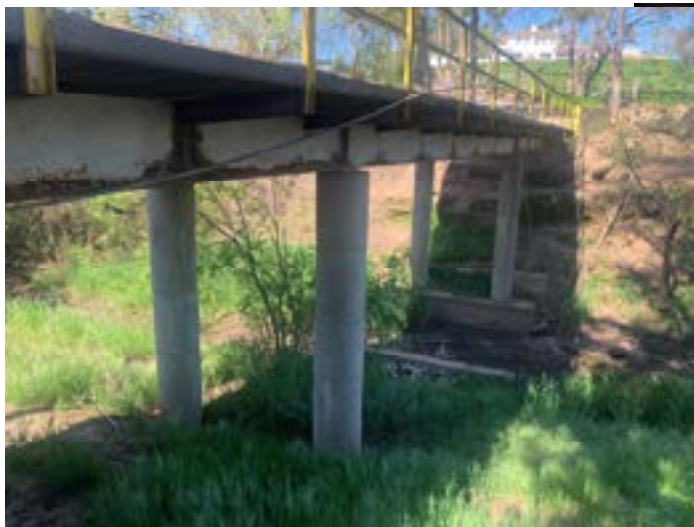
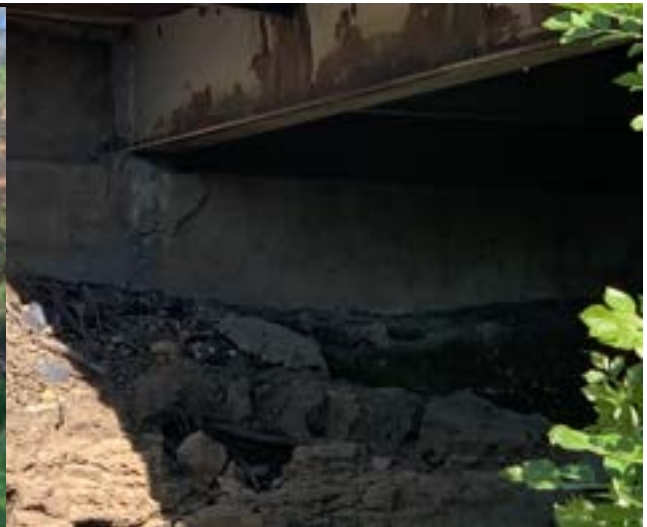
BRIDGE 14 ADELINE PODESTA

This bridge has a concrete decking slab supported by steel beams. The two steel beams span between the abutments and are each supported by two (2) circular concrete columns jacketed by steel breaking up the span. Steel cross channels extend outward from each steel beam to provide edge decking support. Cracks at the ends of the steel beams in the concrete abutments were observed. A steel channel guardrail could be observed on each side of the bridge.

Bridge Rating - 8.

This bridge appears in very good condition. The concrete cracks in the abutment should be patched using an epoxy system to minimize future difficulties. The steel beam surfaces appear to be dilapidating and should be properly protected.

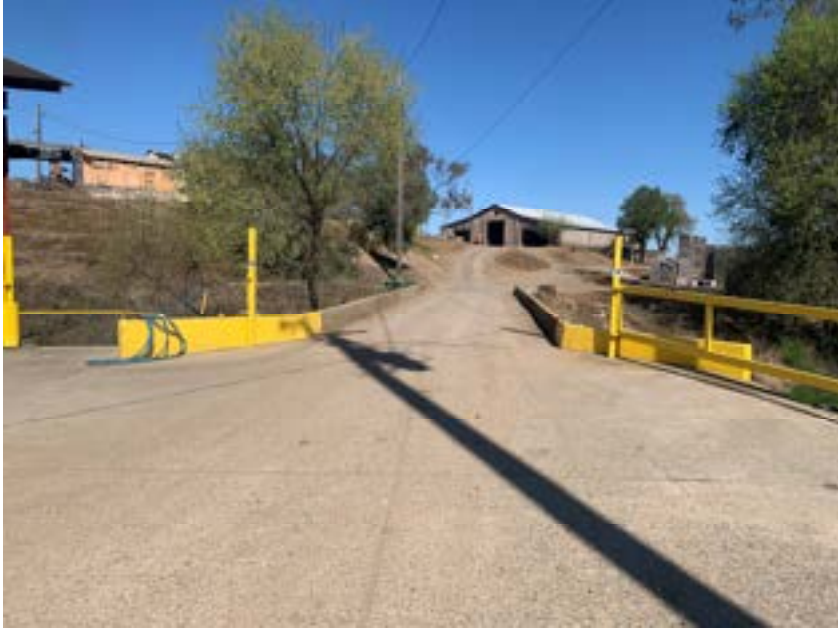
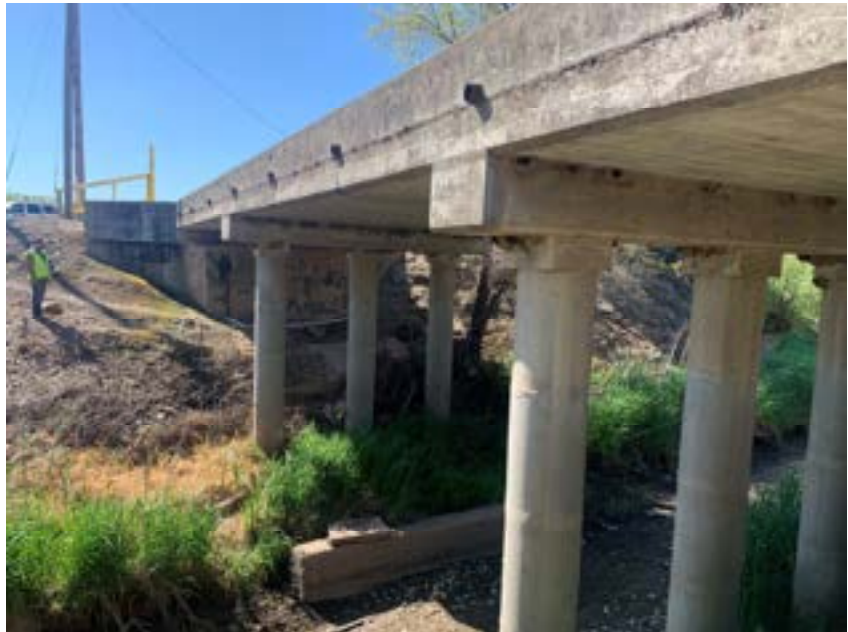
BRIDGE 15 PODESTA

This bridge has a flat slab concrete deck with a 16" to 18" high concrete curb on each edge. The concrete flat slab is supported at each end with

concrete abutments and two (2) concrete crossbeams breaking up the span. Each concrete crossbeam is supported by three (3) circular concrete columns bearing on a concrete foundation grade beam. No guardrail was observed at the top of the concrete curb.

Bridge Rating - 9.

This bridge is in excellent condition. The addition of a guardrail as previously described should be considered for safety purposes.

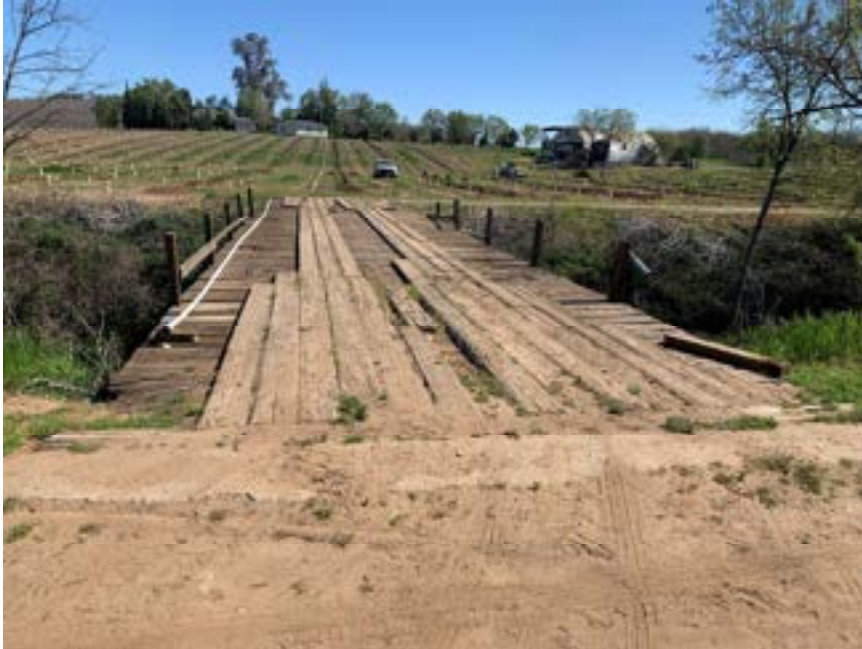
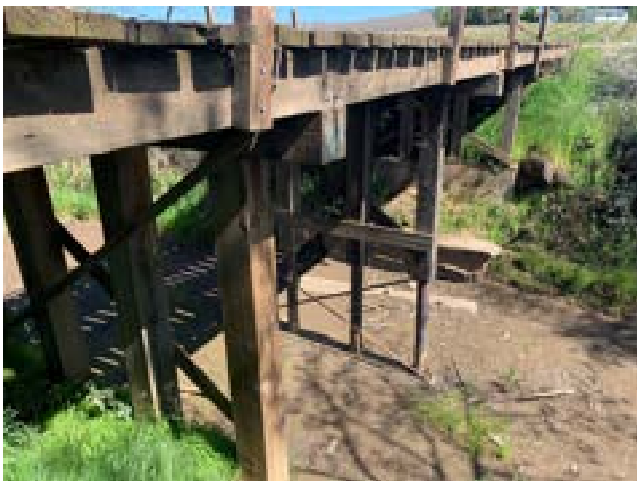
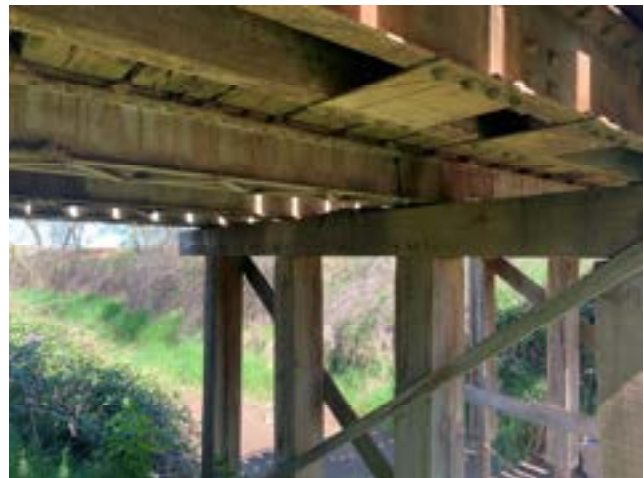
BRIDGE 16 GOTELLI

This bridge has wood decking supported by three (3) steel assembly beams. The steel assemblies are made up of steel channels with connecting steel plates to the top and bottom flanges in a crisscross pattern. The steel assemblies span below the bridge to provide support for the vehicle tire path above. The steel assembly beams span between concrete abutments at each end and are supported by four (4) wood crossbeams breaking up the span. Each wood crossbeam is supported by four (4) "wood/steel" posts. Each of these posts is wood for the top half and steel pipe for the bottom half. The row of steel pipes is supported by a concrete grade-beam. No guardrail was observed although vertical wood posts from a presumably previously existing one could be seen.

Bridge Rating - 6.

This bridge support structure is in fairly good condition. The wood decking will need to be repaired or replaced soon. The strangest item is the support columns being constructed of partial wood and partial steel pipe. The connection between the two elements is generally discouraged because this condition creates a hinge where buckling of the column could occur. These columns should be replaced with either full-height wood posts or full-height steel pipes. The addition of a guardrail as previously described should be considered for safety purposes.
